# Give. Sympathize. Control. Subverting the GZM48S Lawnmower via CAN\*

Nick Black, Consulting Scientist nickblack@linux.com

#### Abstract

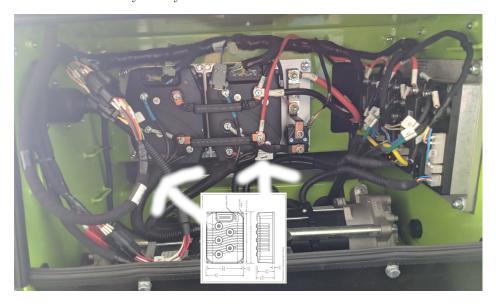
Figure 2: GZM48S electrics bay, and diagram of Curtis 1234. It's a match!

The Owner's Manual rewards a close inspection. The diagram and accompanying text suggest presence of both a "master" and "slave" controller. The terms could suggest a failover protocol at work. CAN itself is a multi-master protocol, but the CiA's CANopen[4] higher-layer protocol does have a concept of masters and slaves. Note that it is implied that the master speaks to the BMS (Battery Management System) and deck<sup>5</sup> motor controllers, but that both the master and slave speak to the HPD. "KSI" pretty clearly means "Key Switch Input", but what's an HPD? Human Protection Device? Searching for this term in a CAN/industrial context pulls on a thread which unravels to suggest that our two drive controllers are Curtis 1234[8] AC Induction Motor Controllers, eventually confirmed via visual inspection<sup>6</sup>. The 1234 speaks CANopen, and can be configured as a CANopen master or slave. Later use of the term "CAN NMT" would seem to refer to CANopen's Network Management Protocol, of which there is no concept in raw CAN. Indeed, we find CANopen NMTs in the packet captures. Realizing this was a critical step in making sense of some of the more complex CAN frames. Always study the documentation!
